Lower Colorado River Multi-Species Conservation Program

Hart Mine Marsh

2016 Annual Report

Work conducted under LCR MSCP Work Task E9

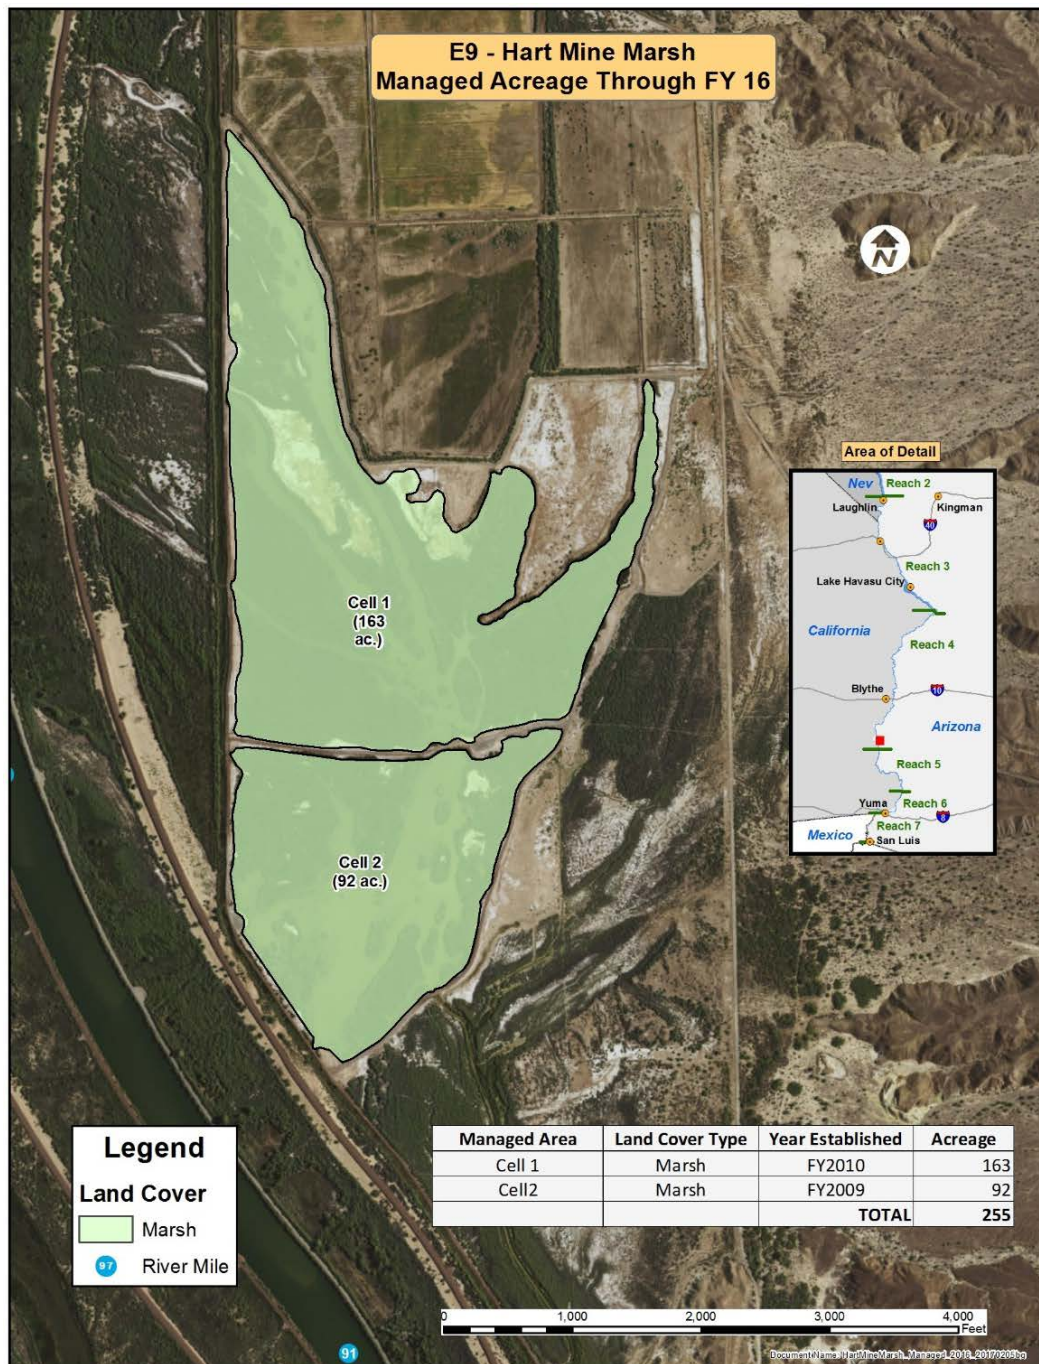
Figure 2.—Managed acreage at HMM through FY16.

Figure 2 shows the established land cover types that are being managed for LCR MSCP covered species.

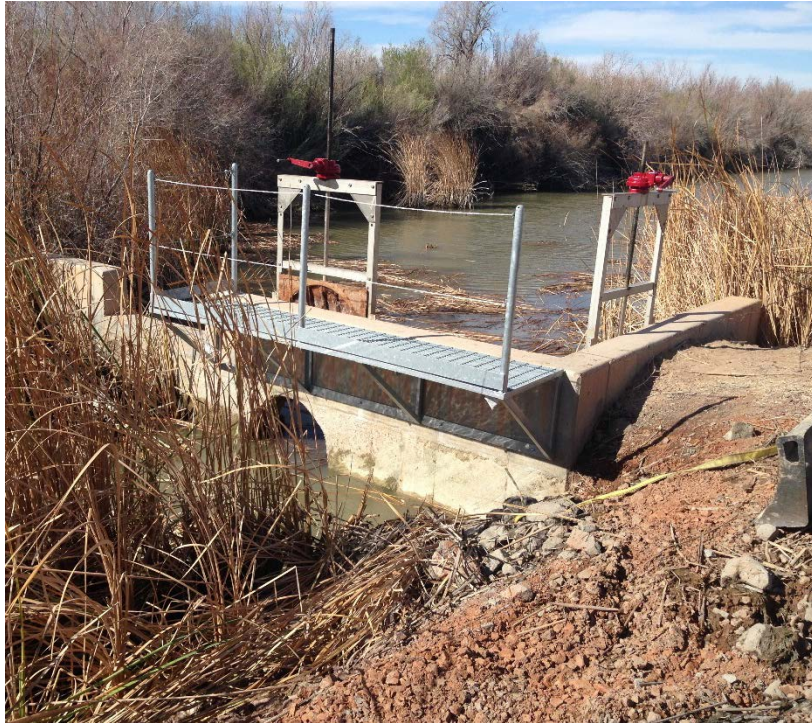
Figure 3.—New catwalks and gate cranks.

Irrigation infrastructure upgrades were completed and included replacing the catwalks and gate cranks on Arnett Ditch and HMM structures (figure 3). The gates can now be operated by gas-powered actuators. Arnett Ditch was also cleared of overgrown vegetation, mainly cattails (*Typha* spp.), to help with water delivery and to improve system function (figure 4). Work was completed through a partnership between Reclamation and the USFWS.

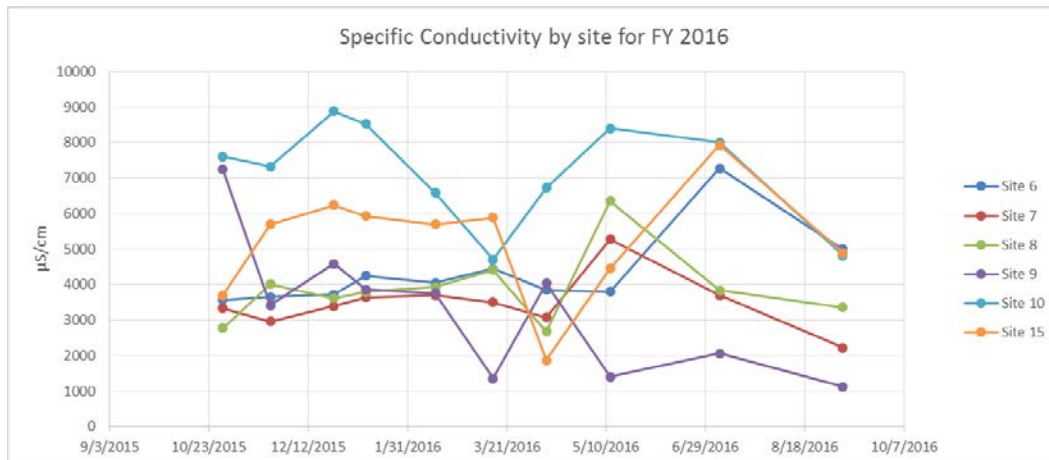
Figure 5.—HMM specific conductivity in microsiemens per centimeter (µS/cm), FY16.

Management at HMM also includes the management of water quality parameters. Most of these parameters have not been problematic to date, with the exception of rising salinities throughout the summer months. This problem has been effectively controlled through regular pumping of Colorado River water into the marsh via Arnett Ditch. Although there appears to be a lag before salinities fall, this method has kept salinities below marsh thresholds (figures 5–7). Additional future water management actions to control salinities and long-term salinization may also include the dewatering and flushing (refilling with Colorado River water) of Cells 1 and 2. This would also occur outside of the breeding season for Yuma clapper rails and would likely be conducted for one cell at a time to allow some flooded habitats to remain for resident Yuma clapper rails and other species during this management activity.

In general, water quality varied from site to site and across seasons. Because very high salinities can affect vegetation, and, in turn, impact wildlife species, management activities at this time only targeted specific conductivity. Salinities were effectively controlled by pumping Colorado River water into HMM via Arnett Ditch. Figures 6–8 illustrate the variation in specific conductivity throughout the year and show the drop in salinities at each site when management action (February pumping, flushing, and refilling) has occurred. They also depict the values for dissolved oxygen and pH at each sampling site and show the fluctuations in water quality between these sampling intervals. A complete water quality dataset for the fiscal year is posted internally on the LCR MSCP SharePoint site and is available upon request.

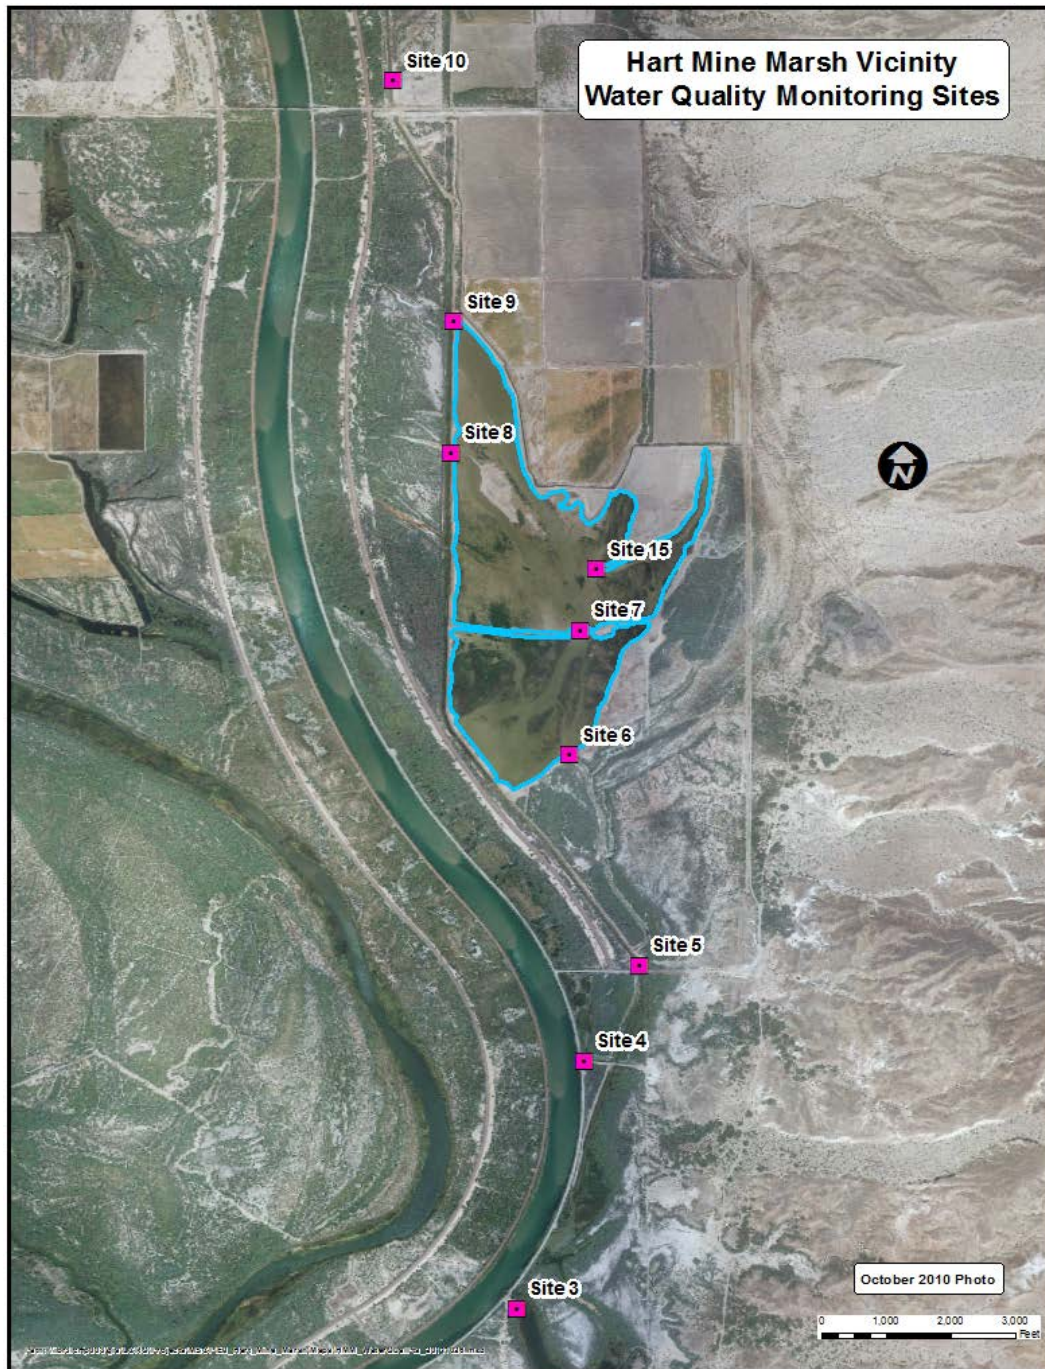
Figure 8.—HMM water quality monitoring locations.

The USFWS is responsible for monitoring and reporting on many abiotic parameters in addition to management of water levels in the marsh throughout the year and during the annual flush. This work is completed through an interagency agreement with Reclamation. Water quality parameters, including specific conductivity (as a measurement of total salinity), pH, and dissolved oxygen, were measured throughout the fiscal year. Figure 8 shows the locations (sites) where water quality parameters were measured and collected.
